# Gates service document

Gates\_MkV Last revised 190418

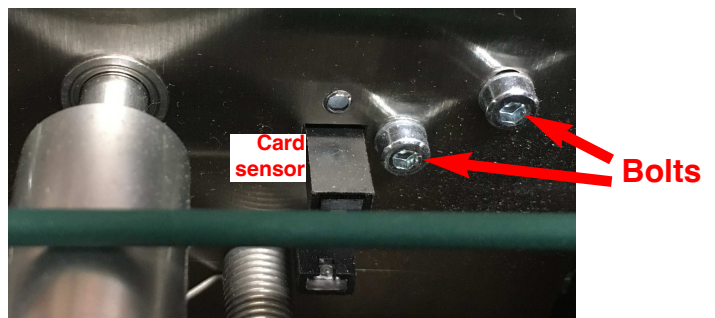
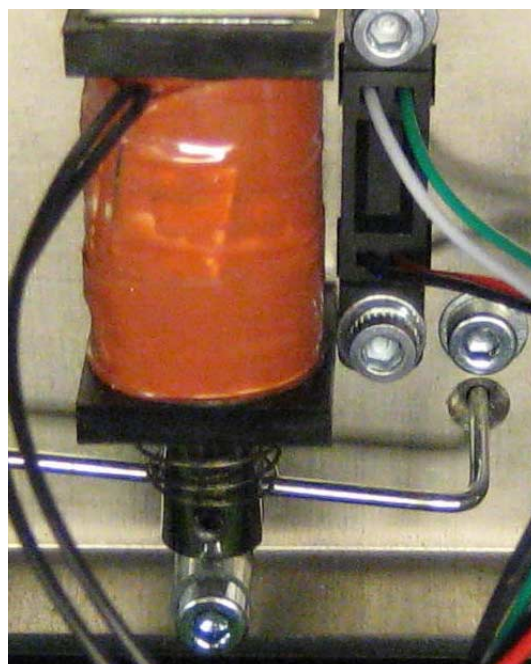
2. Insert a card by hand. [Start Hardware Diagnostics](#) Gate test and check that the distance between the opened gate and the card's edge is  $\leq 1.5$  mm if NOT Prim  
no maximum if Prim

Adjust by moving the solenoid up/down. You need both a 2 mm and 2.5 mm allen key for this. The bolts are reached from the card path, see the upper image to the right.

**Note** that the solenoid shall be "just passed 12" when you lock its bolts, see the lower illustration to the right.
