# Gates service document

Gates\_MkV Last revised 190418

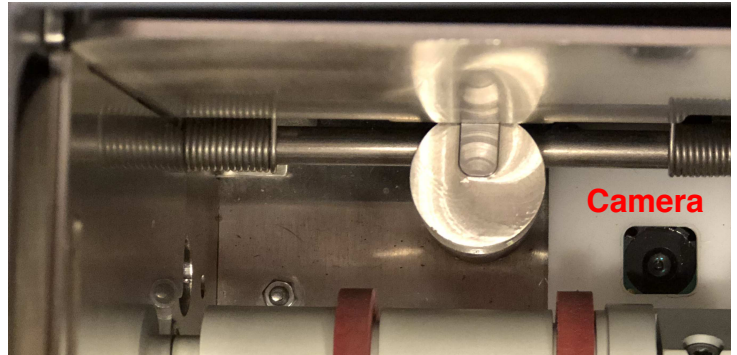
You should consider to upgrade your machine to the Prim standard if you have a machine with inbuilt light in the camera house (see illustration to the right) as the Prim model has a greatly improved gate function.
